Analysis of Safety Measures in Old Government Schools Building for Multi Hazards. A Case Study of Hashtnagri, District Peshawar

Syed Azmat Ali Shah^{*}, Nouman Alam[†], Khan Shahzada[‡], Wajid Ali[§] and Amjad Ali^{**}

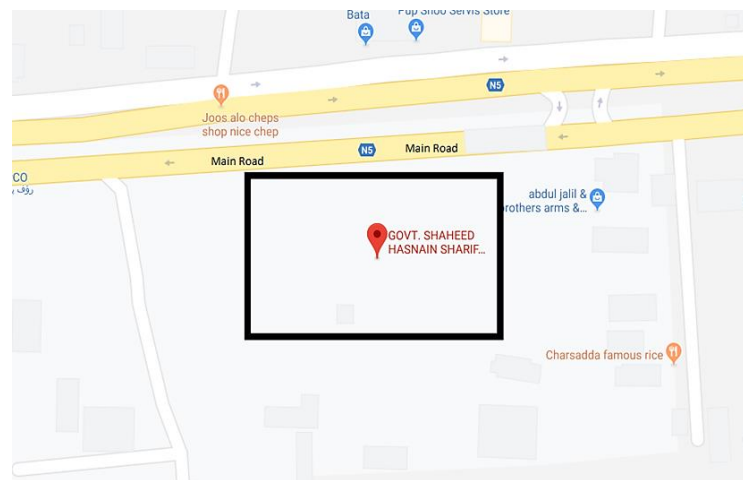
Fig. 3. Single Road Access To The School Building

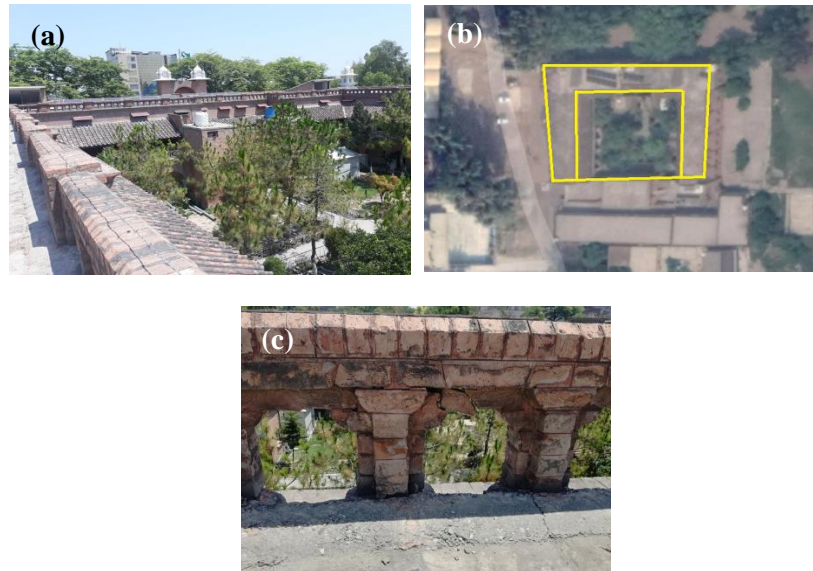
SEISMIC HAZARD		
	Architectural Issues	Seismic Compliance
A1	The Shapes are asymmetrical, and structure is having no joints	0.05
A2	The story elevation is alike (i.e., but contrast by < 5%); irregular elements are not present	1
A3	The school building is not suitable for disabled people	0.1
A4	There are exit passageways which has a width less than 2.4 m but more than 1.2m, and are well lit, not so difficult to identify and to use during emergency	0.75
A5	Windows are provided without glasses	NA
A6	Wall have no tiles at all	NA
A7	Parapets walls are weakly attached	0.05
A8	There is Moderated level of difference of length/ breadth/ height ratio from safe limit	0.5
A9	All walls and columns of the building are constructed in a network & some (<15%) not in network in other direction	0.75

Fig. 4. (a) Irregular Shape (b) Rectangular Shape (c) Eroded and Non-Restrained Parapet Walls

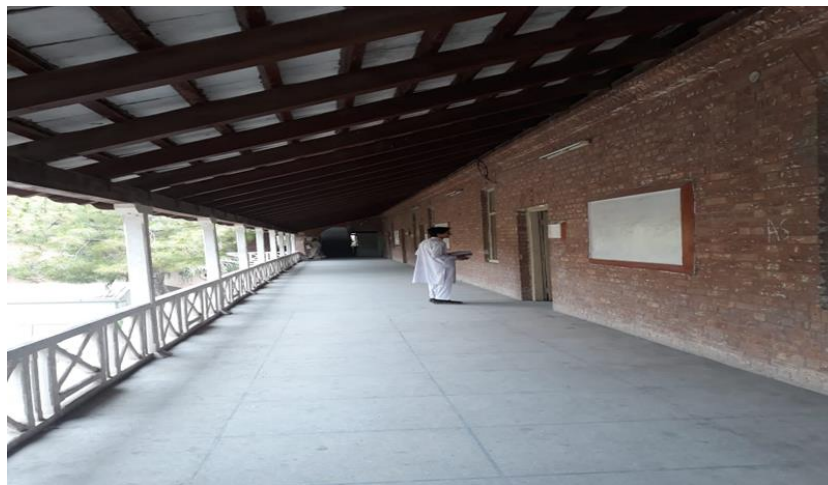
There is one main road that is enough for fire vehicles to operate during fire emergency. Wood materials are used in the roof and windows of the building which make it vulnerable for fire hazard as shown in the Fig. 5. Fire compliance related to other issues are given in Table 6.

Fig. 5. Roof With Wooden Materials

In structural issues of a building it must be kept in mind that the structural members must be insulated in order to get safe from fire. In the school under study, fire prone material like wood was used in the building which can increase the building vulnerability to fire hazard as shown Fig. 5. Fire compliance for structural issues are given in Tables 8.

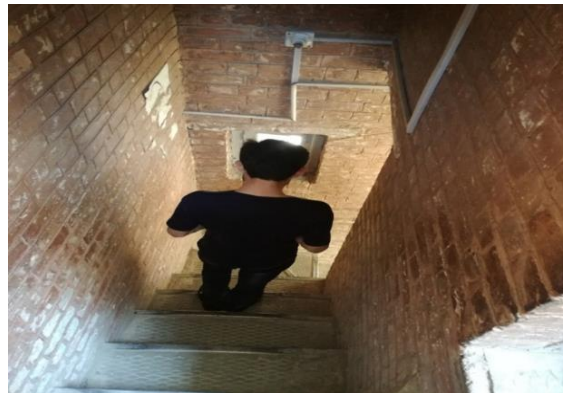
Majority of the stairs in the school can cause further damages during fire emergency because the stairs are not enough wide to support

more than two students during evacuation as shown in Fig. 6. Fire compliance for architectural issues are given in the Table 7.

Fig. 6. Stairs with Small Wideness

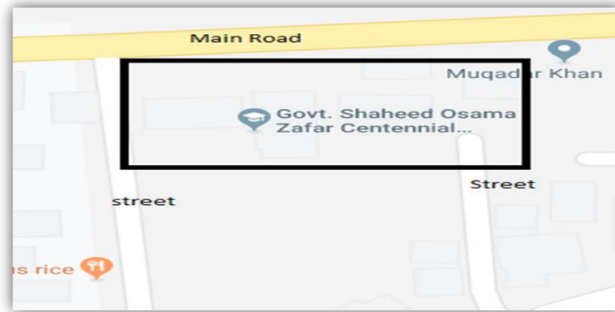
The school building can access by one main road and two streets during the emergency situations as shown in Fig. 7. Other issues related to planning are given in Table 10.

Fig. 7. One Main Road and Two Streets Access to School Building

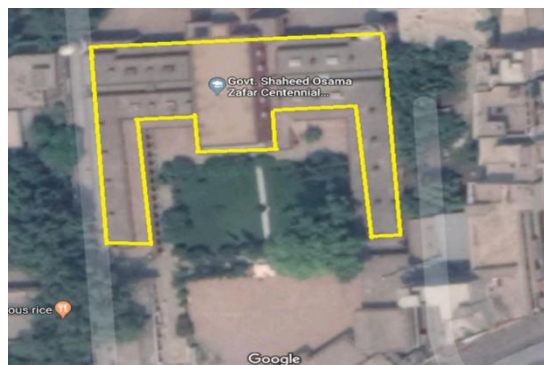
School building under the study was W-shape with irregular structure. Parapet walls were eroded and not restrained at all. Story heights

Fig. 8. W-Shape School Building

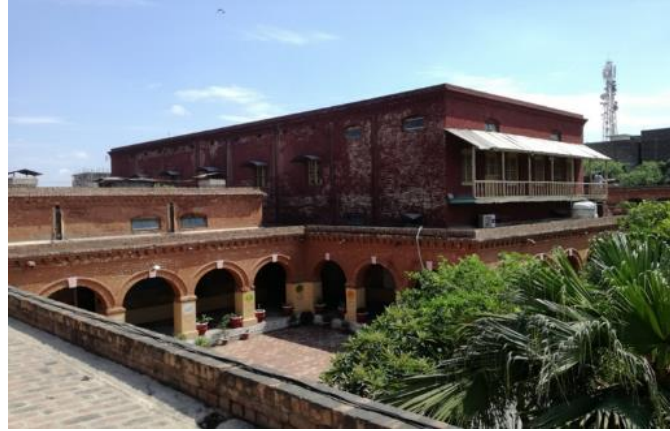
Fig. 10. Parapet Walls Not Restrained to the Roof and Fallen on the Left Side

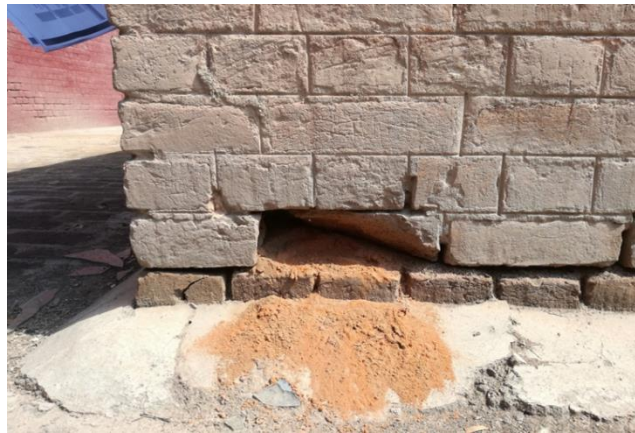
The material used in the construction has been eroded. There are many cracks in the walls of the building.

Fig. 11. Eroded Wall of Building Room

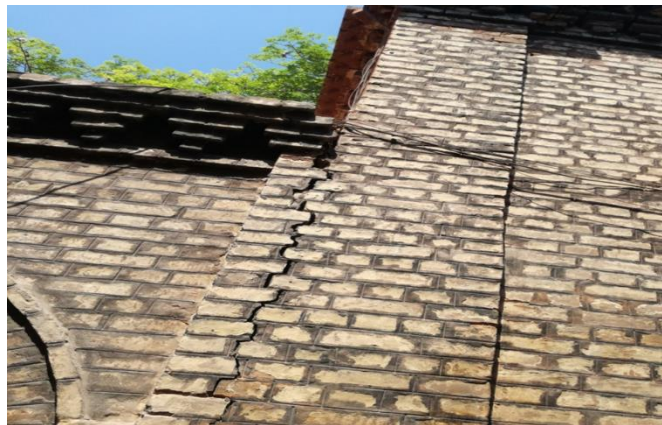
Fig. 12. Wide Crack Between Veranda and Building Room
