Analysis of Safety Measures in Old Government Schools Building for Multi Hazards. A Case Study of Hashtnagri, District Peshawar

Syed Azmat Ali Shah^{*}, Nouman Alam[†], Khan Shahzada[‡], Wajid Ali[§] and Amjad Ali^{**}

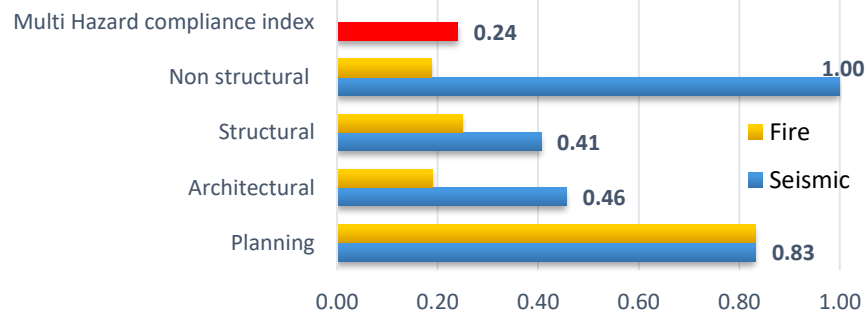
Bar Graph 1: Summary of Compliance for the Top Level Management

Bar Graph 1 shows hazard safety compliance throughout different phases which includes planning compliance that is 83% for seismic and 83% for fire. Similarly, architectural compliance 46% for seismic and 19% for fire. Also, the graph shows compliance for structural and non-structural members of the building. The compliance of seismic safety for structural members is 41% and 25% for fire while for Non-structural the compliance for seismic safety resulted 100% while 19% fire safety.

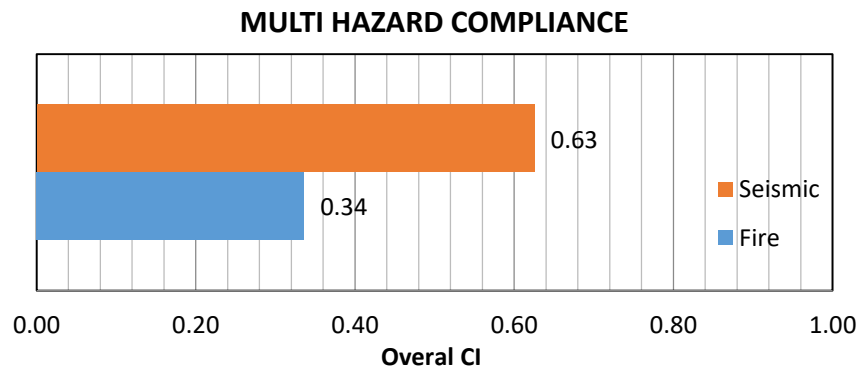
Bar Graph 2. Overall Seismic and Fire Hazard Bar Graph

The assessment of the building for fire and seismic vulnerability indicated that it is 0.34% vulnerable to fire and showing only 63% vulnerability to seismic forces for which the building needs preventive measures against the fire and seismic actions.

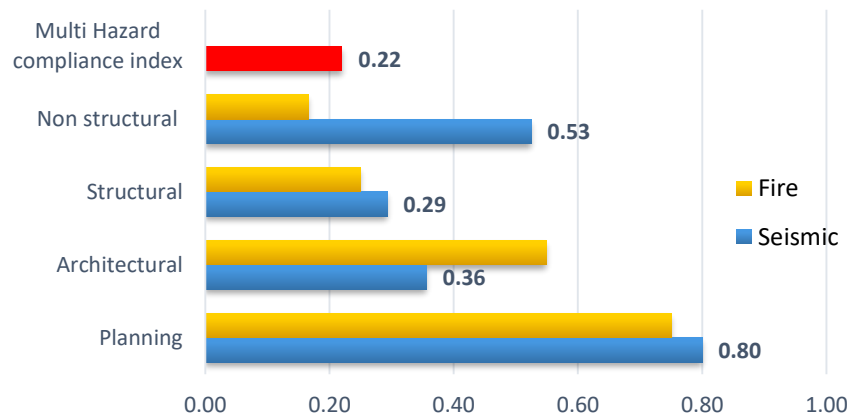
Bar Graph 3: Summary of Compliance for the Top Level Management

Graph showing hazard safety compliance throughout different phases which includes planning compliance that is 80% for seismic and 75% for fire. Similarly, architectural compliance 36% for seismic and 55% for fire. Also, the graph is showing compliance for structural and non-

structural members of the building. The compliance of seismic safety for structural members is 29% and 25% for fire while for Non-structural the compliance for seismic safety resulted 53% while 17% fire safety.

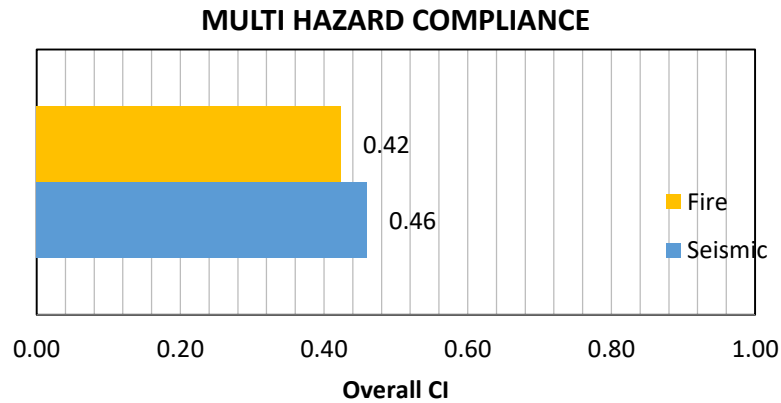
Bar Graph 4: Overall Seismic and Fire Hazard Bar Graph

Bar graph 4 shows the overall seismic and fire hazard bar graph. Assessment of the building for fire and seismic vulnerability indicated that it is 0.42% vulnerable to fire and 0.46% vulnerable to seismic forces for which the building needs preventive measures against the fire and seismic actions. From the above given graph, it is clearly observed that the Govt. Shaheed Osama Zafar Centennial Model High School No. 2 building has to be on emergency based addressed for the fire risk, and fire extinguishing equipment should be provided throughout the building. However, the building is also highly vulnerable to seismic activity at the same time. Therefore, a regular maintenance is required throughout the building for long lasting time and to prevent seismic risk in future.
